**Flood Control Project Maintenance
Levee Inspections**
LMA District Cover Sheet
Spring 2009 Levee Inspection Results

Reclamation District No. 2031

Levee Inspection Report By Mile - Spring 2009

Waterway	Bank	Unit Miles	Inspection Start/End	Inspector
Unit No. 01 Stanislaus River	Left	7.20	05/14/2009 05/14/2009	Herman Phillips

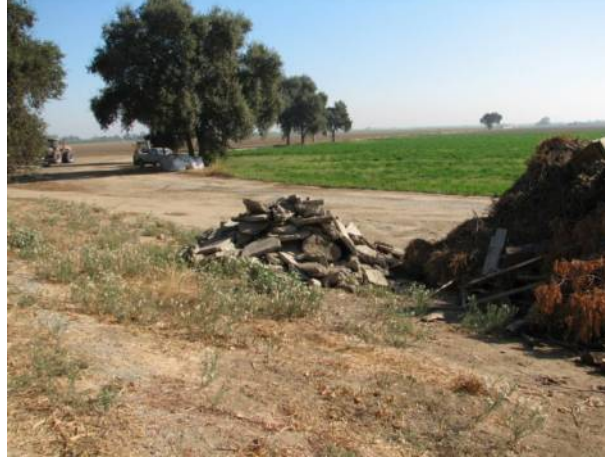
Levee Mile Report Line	7
Start Levee Mile	2.47
End Levee Mile	2.47
Location	Land Side
Category	Earthen Levee
Item	Encroachments

Issue #24 RD 2031 unit 1. Debris on LS within 10' of toe must be removed. We spoke with the responsible party and were assured removal would occur soon.
